Experimental, numerical and field study investigating a heritage structure collapse after the 2015 Gorkha earthquake

Abstract

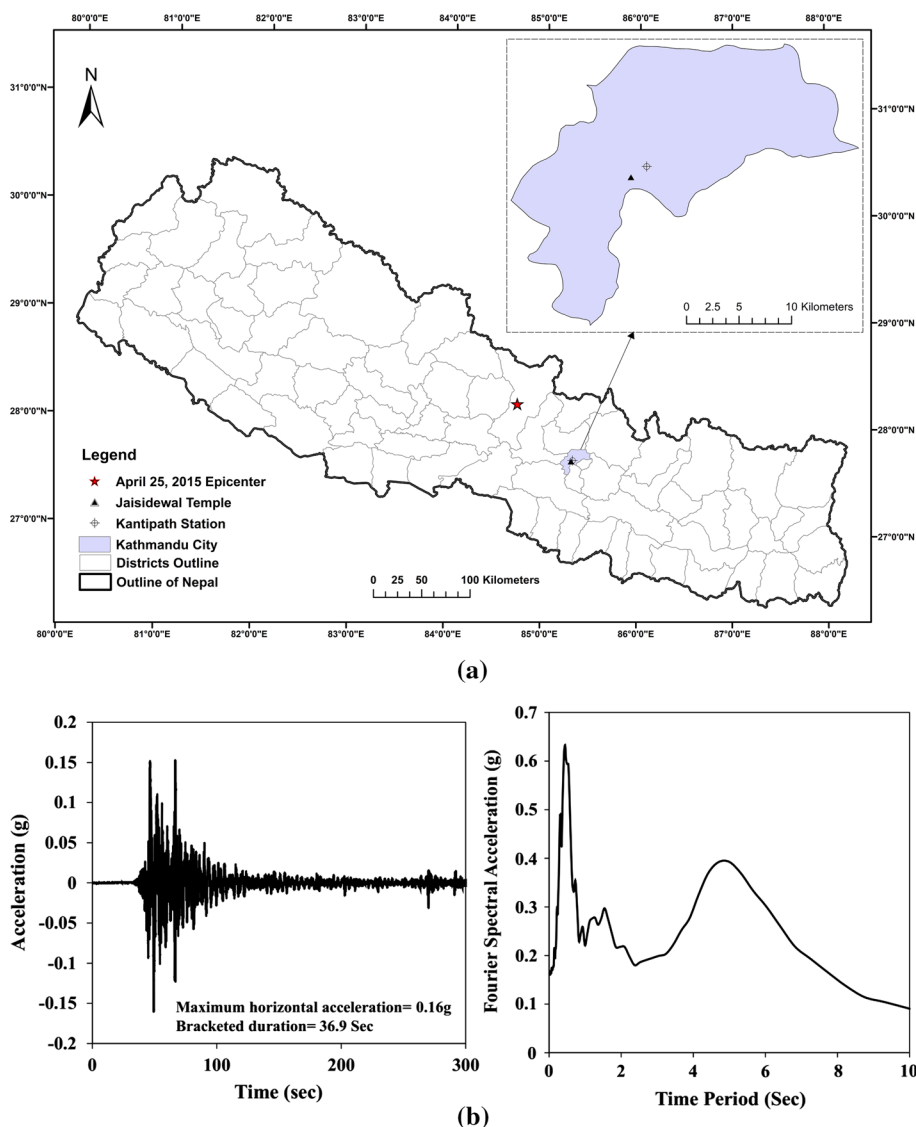
Fig. 1 2015 Gorkha Earthquake: **a** epicentral location, location of Jaisidewal temple and earthquake recording station, **b** acceleration–time history and Fourier Spectrum recorded at Kantipath Station in Kathmandu (27.71235 N 85.31561 E) (Recorded by United States Geological Survey)

i.e. Swayambhu and Baudhanath; and two Hindu temples, i.e. Pashupati and Changu Narayan). On 25 April 2015, a very strong earthquake of M_w 7.8 shook the whole of Nepal and some neighbouring areas of India and China at 11:56 am local time; the main shock was followed by several aftershocks. The epicentre of the earthquake was near Barpak village in Gorkha District, 77 km north-west of Kathmandu as shown in Fig. 1a and had an estimated focal depth of 15 km. Figure 1b illustrates acceleration–time history recorded at the Kantipath recording station in Kathmandu which indicates the maximum peak

horizontal acceleration of 0.16 g, the bracketed duration of 36.9 s (duration between first and last exceedance from 0.05 g in a recorded motion) and the Fourier Spectrum. The Fourier spectrum indicates predominant periods of 0.44 s, and 5 s, respectively.

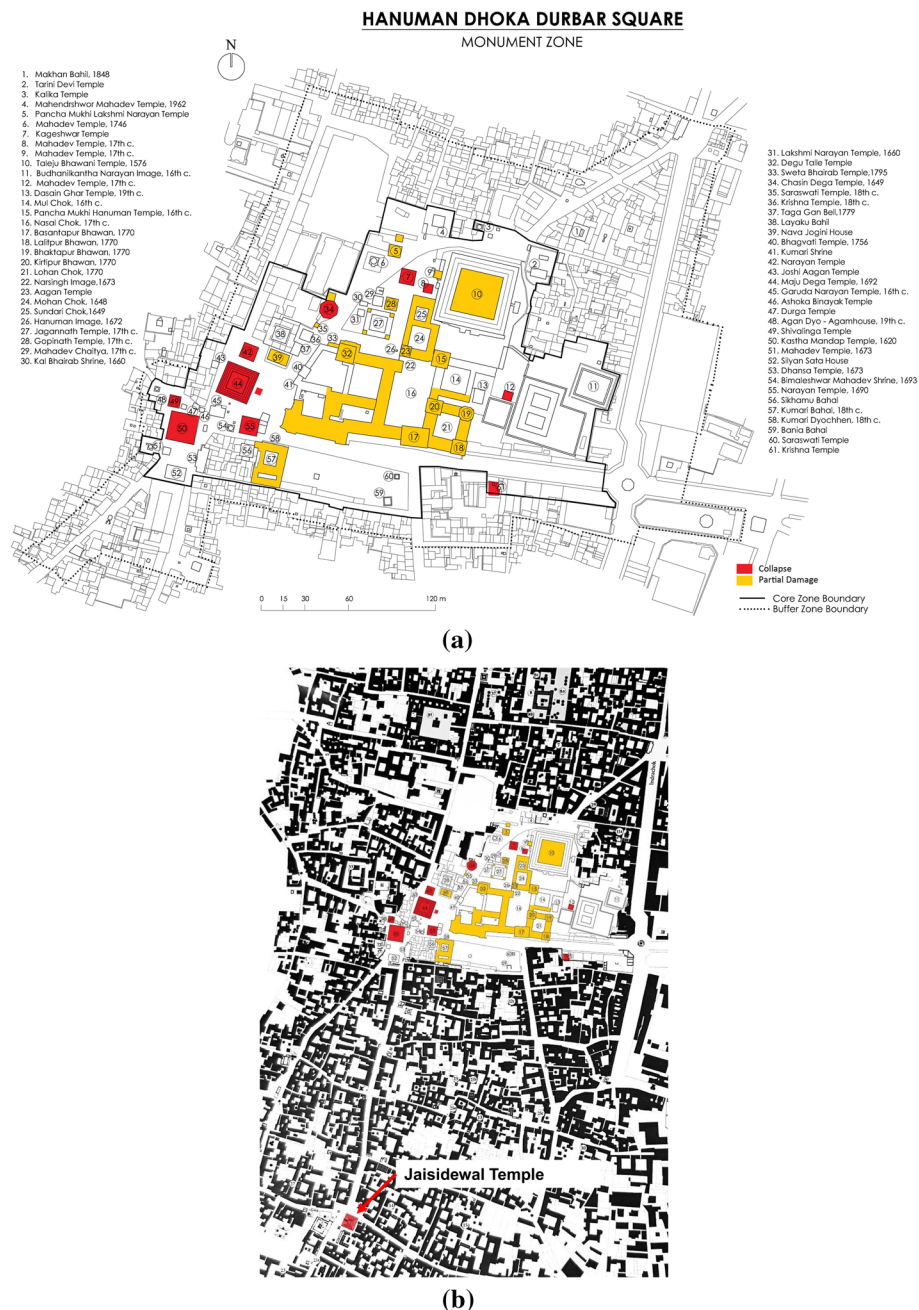
Fig. 2 Condition of Hanuman Dhoka Durbar Square region of Kathmandu after 2015 Gorkha Earthquake **a** details of temples condition, **b** location of Jaisidewal temple (Image prepared by ICOMOS, Nepal)

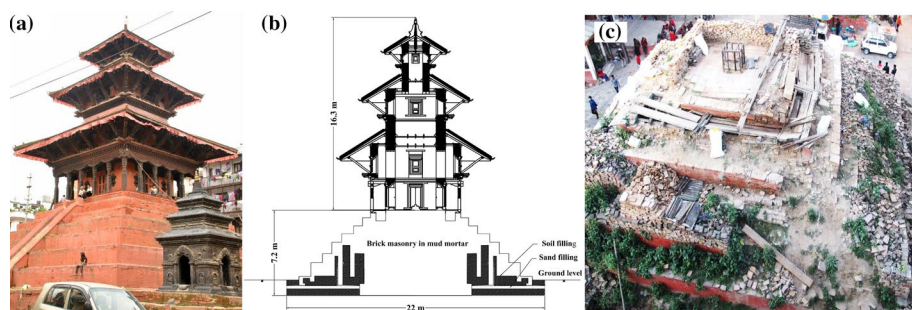
Fig. 3 Jaisidewal temple: **a** schematic representation of the temple (Image: ICOMOS, Nepal) and **b** photograph before 25 April 2015 (Department of Archaeology, Nepal), **c** photograph after 25 April 2015 (Reconnaissance survey)

masonry mat supporting the whole structure (UNESCO 2013). A conical mass distribution resting on a wide base, as shown in Fig. 3a and b, may have helped in distributing shear forces. The concentric support structure with interconnected columns may also have redistributed the shear forces and bending moment that arose during the seismic event; however, as can be seen from Fig. 3b, structural continuity of the columns is not maintained. This reduces the ability of the upper portion of the temple to withstand earthquake lateral forces. The heavy weight of the upper columns made of brick masonry and tiles covering the roof result in the earthquake, generating large inertia forces that need to be resisted. Furthermore, poor connectivity between the multi-layer brick masonry and the timber composites would have further decreased the seismic resistance of the structure. Although this temple survived the 2011 Sikkim–Nepal earthquake and 1934 Bihar–Nepal earthquake, the superstructure portion of the temple having a height equal to 16.3 m collapsed during the 2015 Gorkha earthquake (Fig. 3c), whilst adjacent reinforced concrete structures suffered only minor damage due to the use of modern construction techniques. Similarly, ancient one- and two-storey structures nearby suffered minor-to-major damages due to lower inertia or lower out-of-plane forces in the masonry walls. Hence, the lack of structural continuity of the columns, low bending and shear stiffness of the masonry walls, degradation in bonding between masonry walls and timbers and insufficient timber joints were the most likely primary cause of the collapse of this temple during the 2015 Gorkha Earthquake. However, the response of a structure during an earthquake does not solely depend on the performance of the structure itself but also on the local geology, foundation parameters and earthquake motion characteristics. To obtain the subsurface conditions at the site, during December 2017, a geotechnical investigation was carried out adjacent to the temple plinth.

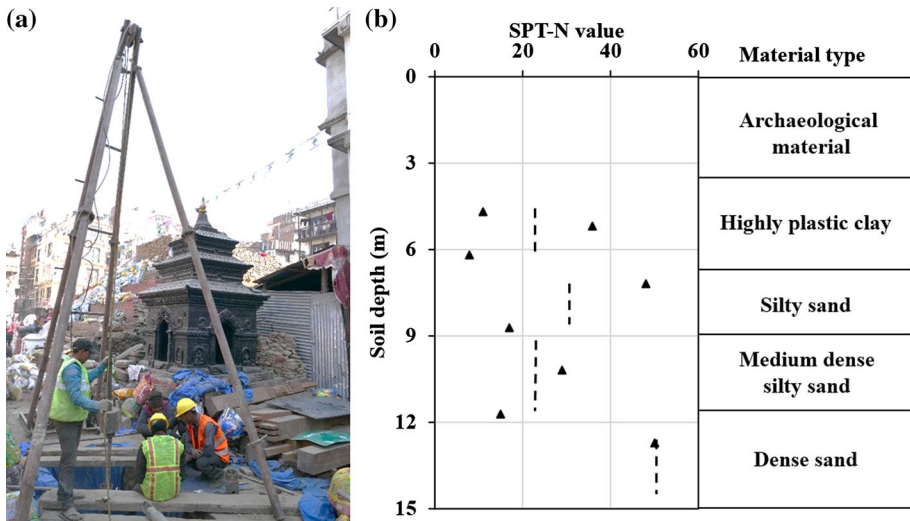
Fig. 4 Jaisidewal: **a** ongoing drilling operation, **b** SPT profile and material type

Very limited information was available on the geotechnical properties of soils present within Kathmandu's World Heritage Site. Hence, a borehole was drilled by cable percussion drilling after careful recording and removal of archaeological materials present via an archaeological trench, located adjacent to temple, excavated to 3.5 m depth, as shown

in Fig. 4a. The borehole was drilled from the base of the trench for a further 10 m giving a total depth of investigation of 13.5 m from the ground level. Archaeological excavation was performed to avoid unrecorded destruction of archaeological deposits within the World Heritage Site and also to provide evidence of pre-existing subsurface structures. During drilling, Standard Penetration Tests (SPT) were conducted in the borehole at 1.5-m intervals and soil samples were collected for a program of engineering testing and characterisation. The recorded SPT-N value ranged from 8 to 50 for the full depth of borehole (13.5 m) indicating the presence of soft-to-stiff soil. The soil stratigraphy along with the SPT-N value can be seen in Fig. 4b. These SPT values rate the soil as a Type C Ground Type according to Eurocode 8 (ECN 2003). Beneath the archaeological material, the top 4 m soil is characterised as blackish soft to medium-stiff clay underlain by dense silty fine to very coarse dense sand. A total of 5 disturbed samples and 3 undisturbed samples were collected from the site and then transported to Durham, UK, for laboratory testing.

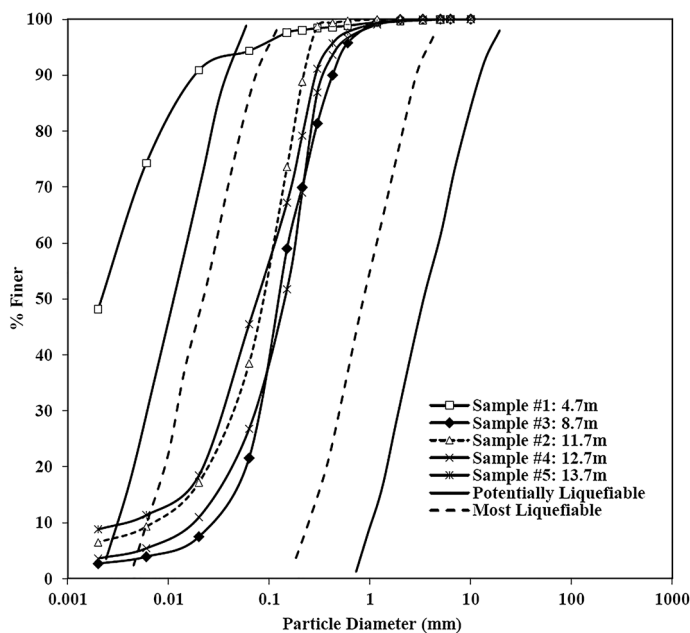
Fig. 5 Particle size distribution and enveloping curve (Modified after Tsuchida and Hayashi (1971) for Jaisidewal soils

Particle size distribution analysis and Atterberg limit tests were carried out on the collected soil samples as per BS 1377 (2016). Figure 5 illustrates the gradation curve for the soil samples collected at different depths and shows a uniformly graded shape for all sands. Table 1 shows the details of the percentage of gravel, sand, fines content and Atterberg limits for the site. From Table 1, it can be seen that the clay layer is highly plastic and is underlain by sands with medium-to-low plastic fines soil at deeper depth.

Seismic liquefaction features of the collected samples were also studied based on the particle size distribution and plasticity characteristics. Figure 5 shows grain size boundary curves indicating the range in which soils are most susceptible to liquefaction as defined by (Tsuchida and Hayashi 1971). From Fig. 5, it can be seen that almost all the curves for the soil samples recovered fall within the range of most liquefiable to potentially liquefiable. Further, the clays (Liquid limit=54 and Plasticity index=22) present between 3.5 and

7.5 m are placed in Zone C of the Atterberg limit charts proposed by Seed et al. (2003). This indicates that they are susceptible to strength degradation under the earthquake excitation. In spite of this, evidence of liquefaction at the site was not observed during site visits and has not been reported by other researchers. Neither rotation nor differential settlement of the plinth was observed. This may be due to the absence of groundwater at shallow depth when the earthquake occurred in April 2015. This was the beginning of the summer season in Kathmandu, and groundwater abstraction may have been responsible for artificially lowering the water levels as well as being just before the monsoon.

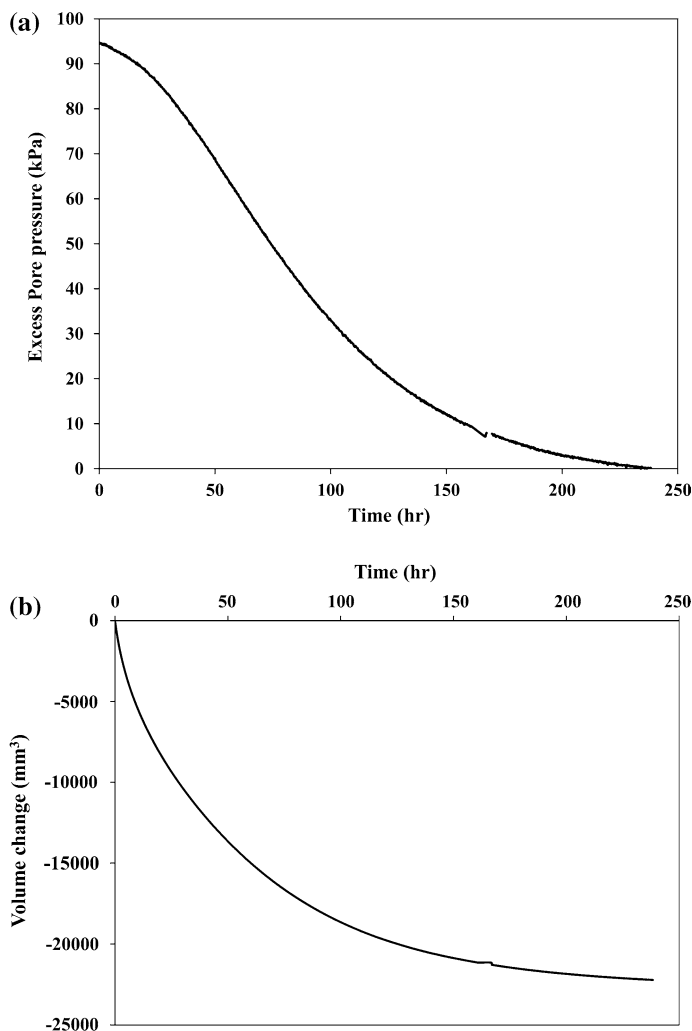
Fig. 6 Consolidation test result at confining pressure of 100 kPa **a** excess pore pressure dissipation with time, **b** volume change with time

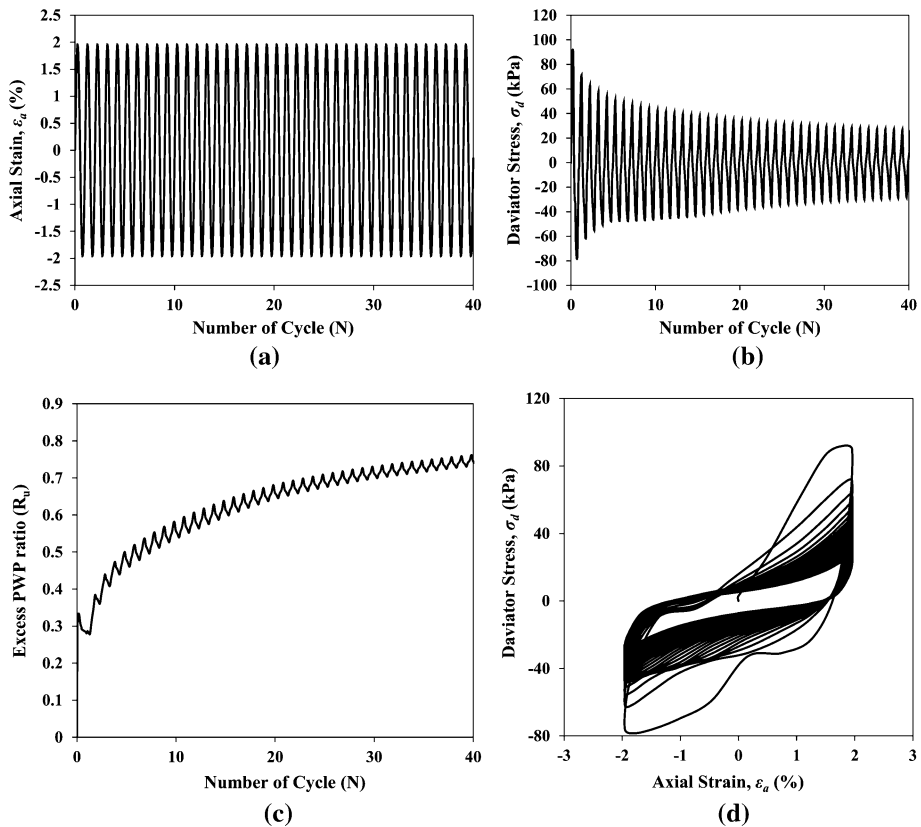
Fig. 7 Cyclic triaxial test results at axial strain, $\epsilon_a=2\%$, $f=1$ Hz, $\sigma_3'=100$ kPa **a** axial strain versus N , **b** deviator stress versus N , **c** PWP ratio, r_u versus N , **d** deviator stress versus axial strain

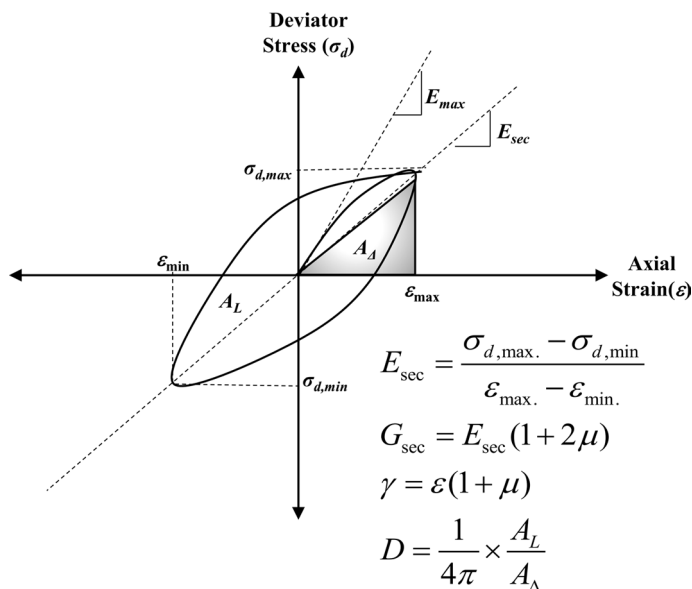
Fig. 8 A typical hysteresis loop obtained during cyclic triaxial test

The dynamic properties of soil can be mathematically evaluated considering one hysteresis loop obtained from particular loading cycle as applied during an experimental investigation. Several researchers have indicated the use of different loading cycles to evaluate the dynamic properties of the soils, i.e. tenth cycle, fifth cycle, third cycle and first cycle. This study uses the first cycle of the hysteresis loop for obtaining the dynamic properties of soil (Lanzo et al. 1997; Vucetic et al. 1998). Figure 8 illustrates the typical hysteresis loop indicating the conventional way to determine the dynamic properties of the soil. This method evaluates the dynamic shear modulus (G) of soil from secant Young's modulus (E_{sec}) obtained by the slope of the line joining the peak of compressive and tensile stress–strain whilst the damping ratio is evaluated from the

stored strain energy by a triangle in the first quadrant (considering a symmetrical cyclic for entire loading case).

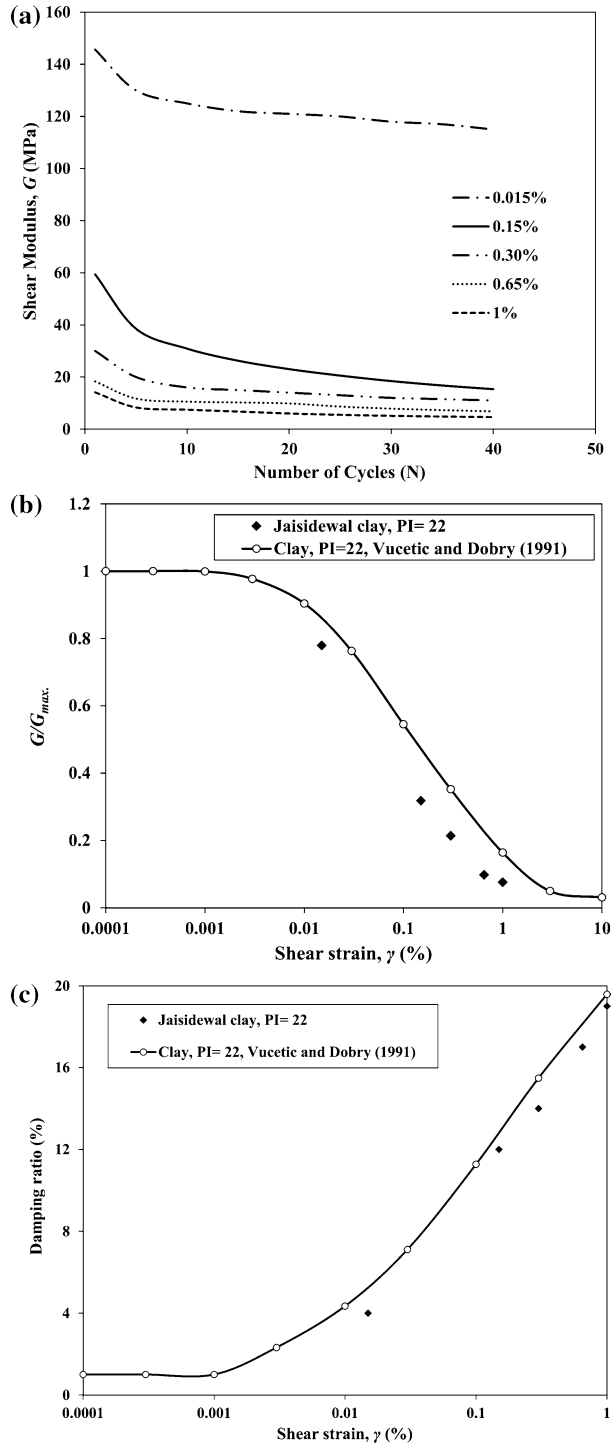
Fig. 9 Cyclic triaxial test results **a** G variation with N , **b** G/G_{max} with shear strain γ (%) and **c** damping ratio with shear strain γ (%) (After Vucetic and Dobry 1991)

Figure 9a illustrates the reduction in the shear modulus (G) of soil with an increase in the number of loading cycles (N) and shear strain (γ). This is mainly because of the hysteresis effect of the soil with increasing strain level, thereby dampening the exciting frequency. A modulus reduction curve obtained from CTX was used to represent the degradation of shear modulus of soil with shear strain (γ) in terms of reduction in shear modulus ratio (G/G_{\max}). G_{\max} is the maximum shear modulus of soil exhibited at very low shear strain ($\gamma \leq 5 \times 10^{-6}$). Since the SPT test was conducted at the site, the maximum shear modulus (G_{\max}) is estimated by back-calculating the shear wave velocity of soil from SPT-N obtained at the site and using the equation given below:

The shear wave velocity of the clay layer is obtained as 317 m/sec considering the average SPT-N value of the clay layer as 27. Again this ranks the site as a Type C Ground Type according to Eurocode 8 (ECN 2003). The maximum shear modulus, G_{max} , is then calculated as 187 MPa. Figure 10b and c shows the modulus reduction curve and damping ratio curves with increasing shear strain level. It can be observed that obtained curves are closely matching with the results reported by Vucetic and Dobry (1991) for clay of PI=22.

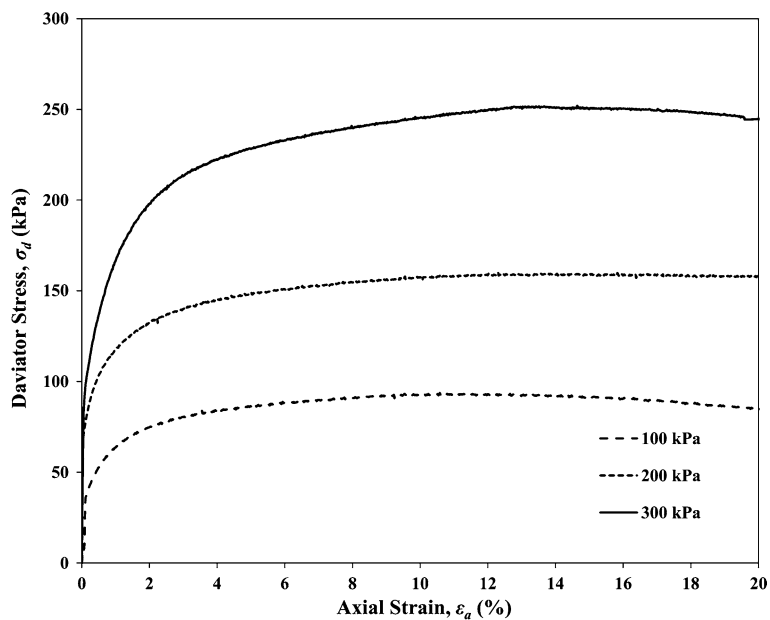
Fig. 10 Deviator stress–strain response of Jaisidewal clay at different confining pressures

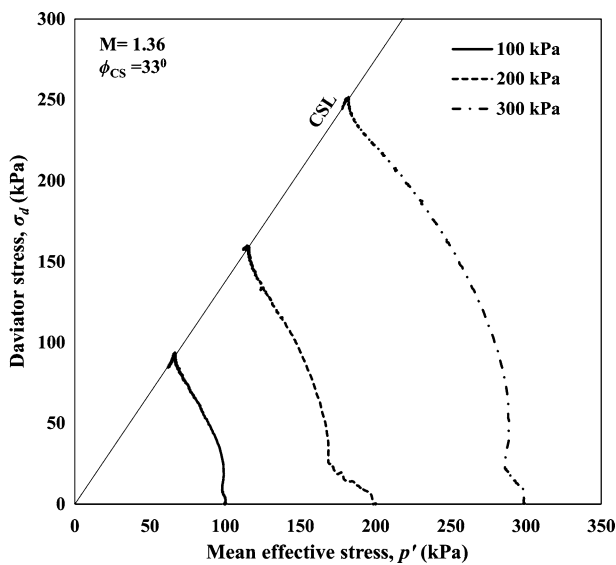
Fig. 11 Stress path and critical state envelope for Jaisidewal clay

where ϕ_{cs} is the critical state friction angle which is the inherent property of the soil. The critical strength friction angle for Jaisidewal clay is 33° . It was observed that the shear strength parameter obtained for Jaisidewal clay was comparable with the shear strength parameters corresponding to SPT values (SPT-N: 27) of the Jaisidewal clay recorded during drilling operation as per Tomlinson (1994). Hence, the shear strength parameters required for conducting the numerical simulation explained in the next section are assumed based on the results of SPT-N values obtained during the drilling operation as per Tomlinson (1994).

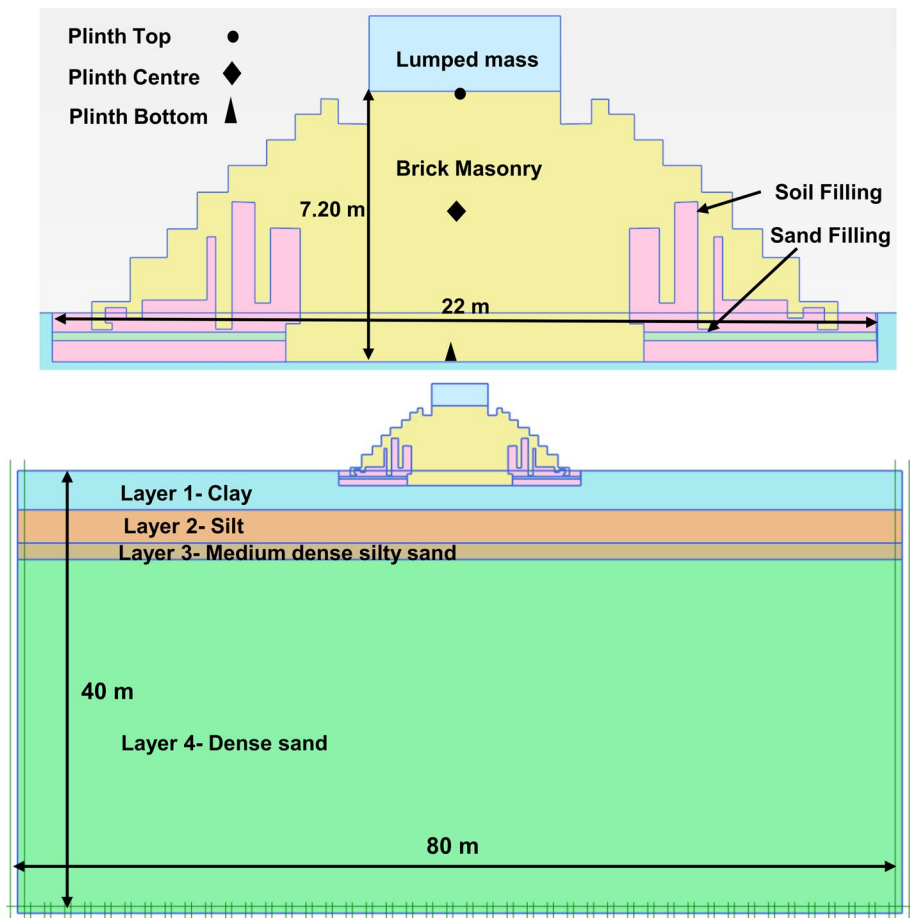
Fig. 12 View of the developed two-dimensional soil-plinth model in Plaxis2D

The assessment of the dynamic behaviour of the Jaisidewal temple was carried out under actual acceleration–time history recorded at Kantipath recording station in Kathmandu by USGS. This was done by developing a two-dimensional finite element model (FEM) with the help of a commercial computer program Plaxis2D (Plaxis 2015), as shown in Fig. 12. Plaxis2D can simulate a nonlinear dissipative response of soil subjected to dynamic loading. Owing to the difficulty in the estimation of the mechanical properties of the temple structural components, lack of established research on traditional masonry construction and to simplify the numerical analysis procedure, a lumped mass modelling approach was adopted to model the superstructure of the temple. The subsoil primary comprised clay, medium silty sand and then dense sand extending to 13 m depth. In the absence of boring data beyond this depth, this study assumed dense sand extending to 40 m depth to attain the requirement of numerical modelling. The conventional Mohr–Coulomb elastic-perfectly plastic constitutive relationship was adapted to model the soils, whilst linear elastic model was adopted for the lumped mass and brick masonry. Whilst the Mohr–Coulomb model cannot simulate the cyclic softening or liquefaction of soil subjected to dynamic loading, Mohr–Coulomb model was felt to be appropriate in the present study to model all the soils as it can capture plastic strains during the cyclic loading. Table 2 shows the model parameters and unit weight of soil and masonry chosen in this study. The geotechnical parameters for the soils of the plinths were adopted from Tomlinson (1994) and Bowles (1997) and for the brick masonry from Pejatovik et al. (2019). The soils were assumed to be in a drained state, and cohesion of 0 kPa was assumed. The model uses 15-noded triangular elements, and meshes in Plaxis are automatically generated using a triangulation technique. A mesh optimisation study was carried out to decide the extents of model boundaries which helped in reducing the computational effort. The lateral extent of four times the size of the plinth and the vertical extent of twice the width of the plinth was adopted to avoid any undesirable boundary effect. The lateral boundaries were fixed horizontally, and the base was fixed horizontally and vertically.

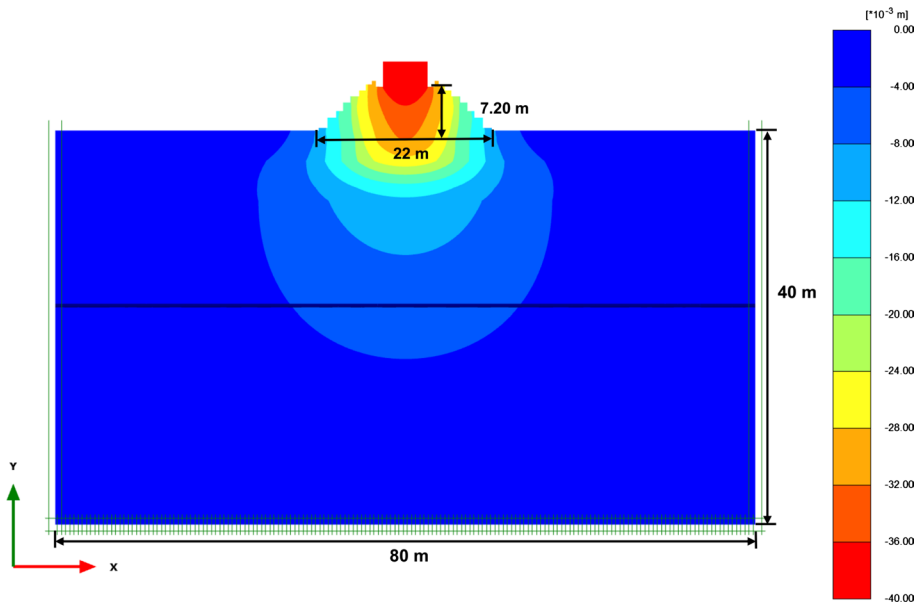
Fig. 13 Deformation contours under static loads of the temple obtained in Plaxis2D

The initial stresses were generated for the soil layers by using the K_0 procedure available in Plaxis to make the model in equilibrium. Thereafter, the plinth was activated by plastic calculations to capture the response and to simulate the construction procedure. This was followed by analysing the model under lumped mass condition. All the components were activated simultaneously with the assumption that the temple would be constructed, following the ‘bottom-up’ method. Similar methodology was adopted by Kumar et al. (2017). The unit weight of the lumped mass was estimated using the schematic diagram of the temple received from ICOMOS Nepal. The total weight of the temple structure was estimated as 1270 kN assuming the uniform unit weight of the material as 20 kN/m^3 as per Sarhosis and Sheng (2014). The settlement of the temple under static loading condition was obtained as 40 mm, as can be seen from Fig. 13.

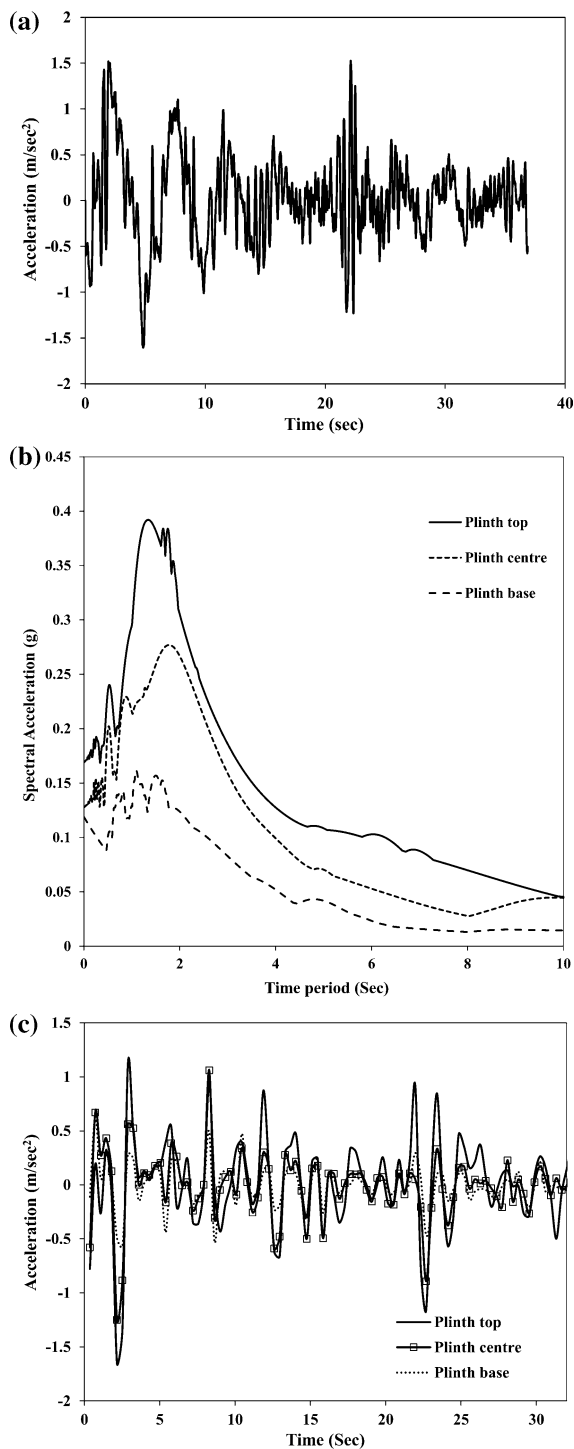
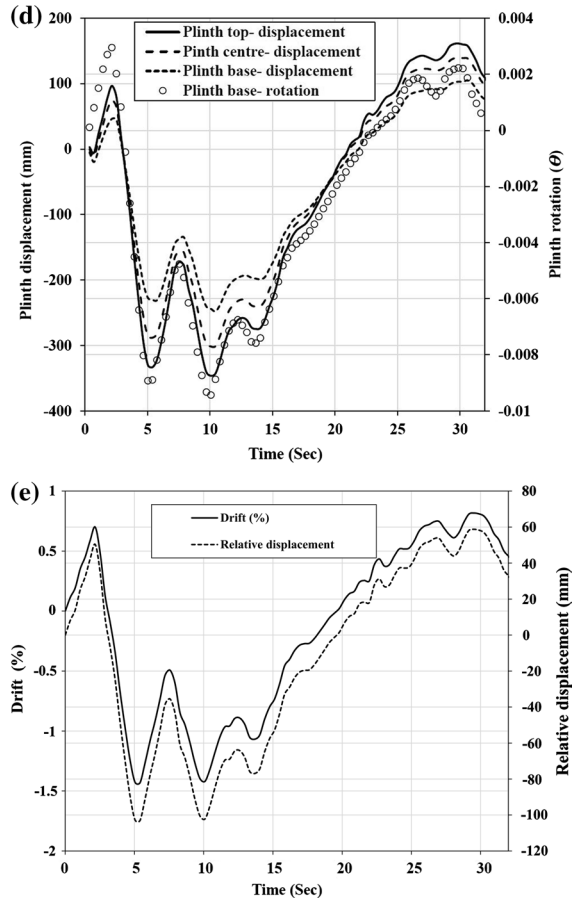
Fig. 14 Jaisidewal temple plinth **a** input motion applied at the base of the soil model, **b** spectral acceleration response, **c** acceleration response and **d** displacement and rotation response, **e** drift and relative displacement repose with the dynamic time

Figure 14b illustrates the spectral acceleration response obtained at different levels of the plinth. It can be seen that the maximum spectral acceleration lies in the range of 1–1.7 s, whereas the maximum spectral acceleration responses 0.4 g, 0.3 g and 0.15 g were obtained at the plinth top, plinth centre and its base. It is to be noted that Jaishi et al. (2003) reported the predominant period less than 0.6 s for the temples in Nepal without considering the influence of local subsoil condition. Considering the local subsoil condition, the fundamental period of site is subjected to period elongation as can be seen from the present study. Figure 14c indicates the acceleration response which indicated the maximum response of 0.15 g at the plinth top with decreasing response along the plinth base. It is to be noted that the plinth of the temple structure was subjected to a maximum displacement of 300 mm during the motion, and residual displacement of 100 mm was calculated. The residual displacement of 100 mm is very high considering the seismic demand of masonry structures. The rotation of the plinth with respect to dynamic time (ratio of difference in the vertical settlement of two extreme edges of the plinth to the plinth width) is obtained which shows negligible residual inclination at the end of dynamic time, as shown in Fig. 14d. Further, the relative displacement is calculated as the difference of displacement obtained between the plinth top and plinth base showing 32 mm of relative displacement, as shown in Fig. 14e. The drift is also obtained by dividing relative displacement with the height of the plinth, i.e. 7.2 m and expressed as percentage. The maximum percentage drift is recorded as 1.4% which may have caused the collapse of the temple structure. This is in line with the guideline given by Uniform Building Code (1991) limiting the inter-storey drift of 0.4% under seismic condition for the building having time period more than or equal to 0.7 s.
